Geophysical data acquisition for a non-invasive diagnosis at the Convitto Palmieri in Lecce

Abstract – **The church of San Francesco della Scarpa is a church in the historic center of Lecce (south Italy) located inside at the Convitto Palmieri. The church has had static stability problems in recent years. In order to understand the causes, a series of findings have been undertaken with the use of integrated non destructive methodologies. Ground Penetrating Radar (GPR), seismic tomography (ST), were used. Results reveals the structural problems of the church.**

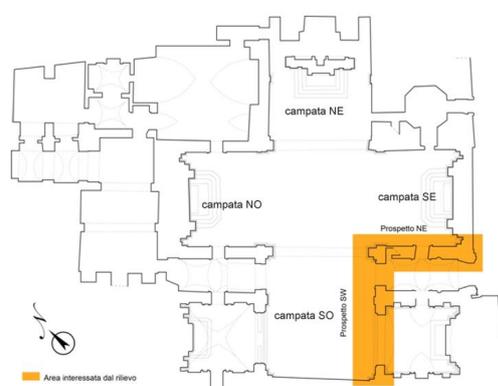
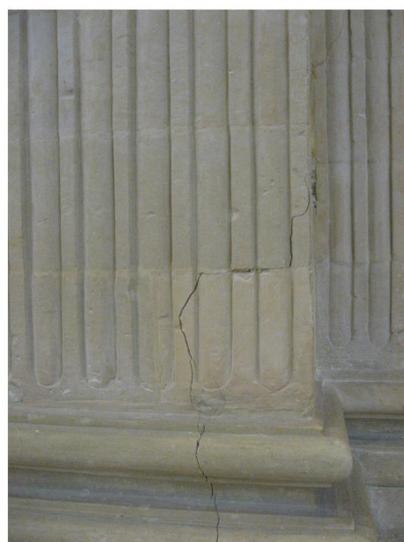
problems of structural degradation have arisen, consisting of a widespread crack pattern on a load-bearing element placed at the intersection of the SO and SE arms of the Greek cross. The cracks that are found are 0.5-3.5 mm wide, mainly vertical and sub-vertical direction and 10-30 cm long which affect the base and the stone cladding of the pillar (Fig. 2).

Figure 2. The area interested by structural problems

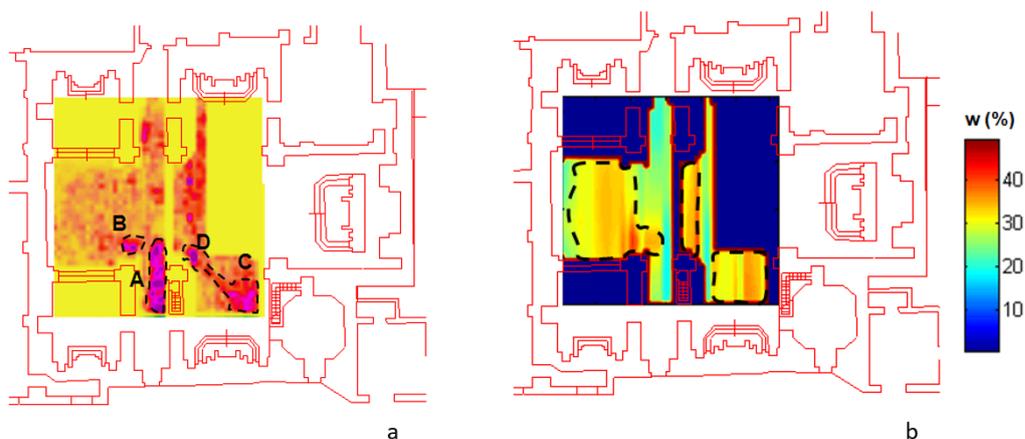
Figure 3 a) depth slice; b) volumetric water content map

From about 1.4m to over 2m radar profiles and time slices image the presence of cavities (fig. 3a), some of them close to the structure affected by instability phenomena. In correspondence with these cavities, the distribution of the volumetric content in water variable from 30 to 40% in the subsoil was estimated (fig. 3b). Seismic tomography prospectings, applied to the structures revealed the distribution of the seismic velocity

The presence near the pillar of cavities, of which a small part was known and in the remaining part was detected by the georadar (figure 3, in particular see anomalies A and D) may have played a decisive role in reversing the behavior dynamic of the masonry structure and in determining the anomalous distribution of the P waves in the foundation, from which, reasonably, the phenomenon of instability manifested itself with the cracking pictures of the pillar, placed at the intersection between the SE and SO arms of the Greek cross plant

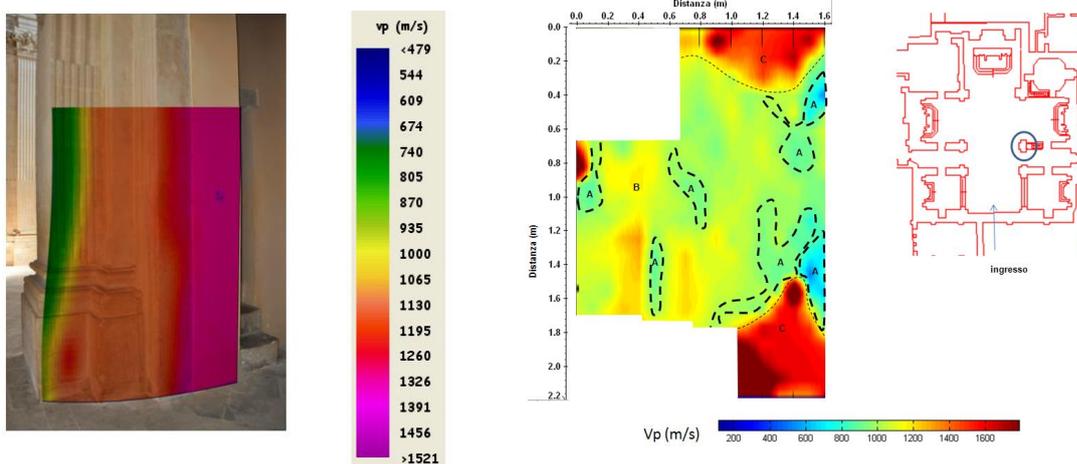
and allow to evidence the presence of weakened points. In the same structures, vertical seismic refraction tomography (fig. 4) detects very low speed values ($800 < V_p < 950$ m /) for thicknesses ranging from 25 to 40 cm. This suggests that the lesions, although characterized by small amplitudes, are not superficial but affect the entire coating and probably the interface between the coating and the bearing core of the pillar.

Figure 4. seismic tomography results

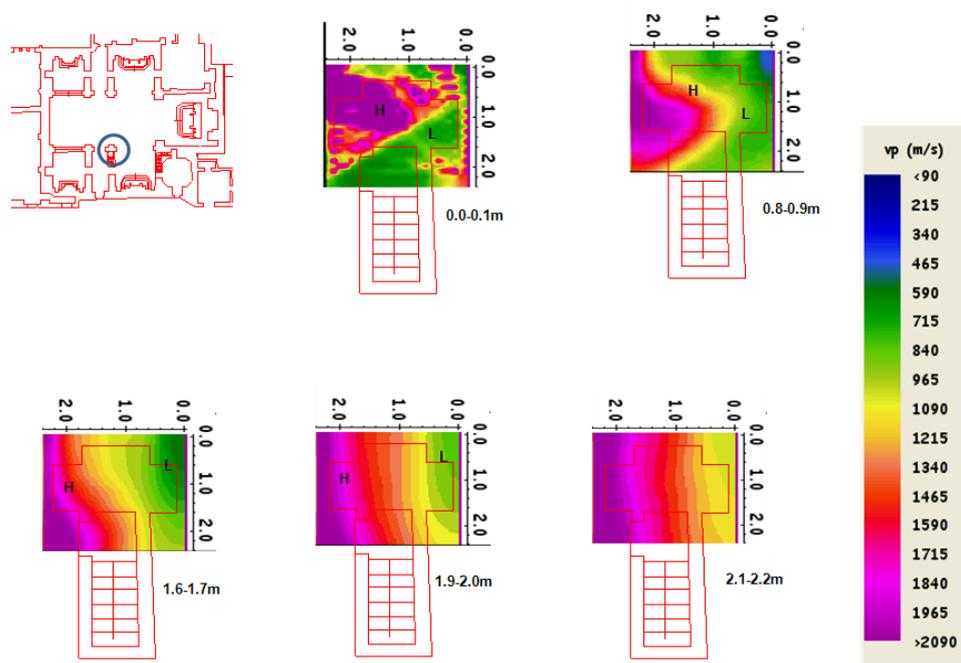
basal part of the wall, ii) the second is a non-uniform soil-structure interaction, as is observed by 3d seismic tomography (fig. 5) which highlights a non-homogeneous distribution of the propagation velocities of the P waves.

Figure 5. seismic wave velocity distribution at several depths
