Integrating Historical Sources and Infrared Thermography for Detection of Seismic Damage in Architectural Heritage

Abstract – This article aims to illustrate a methodological approach for identifying damage scars and reconstruction interventions on monuments affected by past earthquakes. The approach draws on the combined and cross-referenced use of historical-technical sources alongside infrared thermographic surveys, allowing to piece together the chronology and extent of structural interventions over time. To try out and validate the methodology, we focus on two case studies involving churches located in two towns in the Basilicata region (Southern Italy). These sites were struck by two major seismic events in the 20th century: the 23 July 1930 Irpinia earthquake (Mw 6.7) and the 23 November 1980 Irpinia-Basilicata earthquake (Mw 6.8). By examining these examples, we aim to lay out the potential of the method to bring out hidden traces of damage and reveal insights into the repair strategies adopted in response to seismic events.

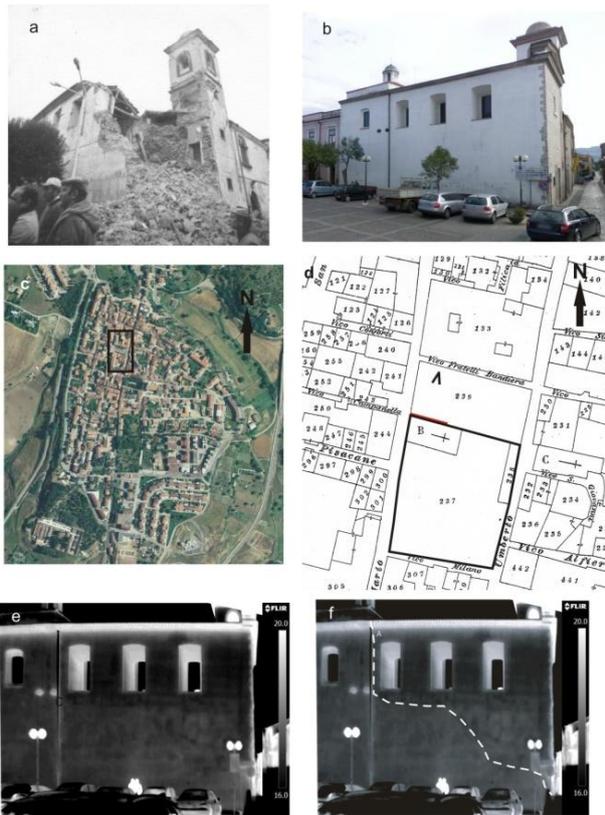
The first nucleus of the building complex of San Benedetto church dates from the mid of the XIV century. The church has a single nave with a barrel vault and lunettes at the sides of the windows. During the 23 November 1980 earthquake there was the collapse of the front gable damaged, the collapse of portions of the side walls of the roof and part of the bell tower (Figure 1).

Figure 1 - San Benedetto church: historical image of the lateral side immediately after the 1980 earthquake (a) actual image of the lateral side (b) localization of the building (c) and localization of the investigated walls (d) heat map of the lateral side (c) and limit/line of reconstruction (dotted line A)

The photograph taken shortly after the earthquake clearly reveals the collapse of the south and east walls of the building (Figure 1a). When this historical image is compared with the more recent thermal image (Figure 1e), a quite distinct boundary becomes visible on the southern façade, delineating the area of reconstruction carried out following the seismic event (Figure 1f). Notably, the extent of the reconstruction appears to be broader than the portion of the wall that visibly collapsed in the immediate aftermath. This discrepancy can likely be attributed to the fact that, although some segments of the southern wall

(particularly those located beneath the windows) did not completely collapse, they nonetheless sustained extensive structural damage. The severity of this damage rendered the remaining sections unstable, necessitating their subsequent demolition and replacement as part of a broader restoration effort. The thermal imagery thus not only highlights the physical boundaries of post-earthquake interventions but also provides insight into the decision-making process regarding structural safety and the scope of reconstruction beyond what was immediately apparent from the visible damage.

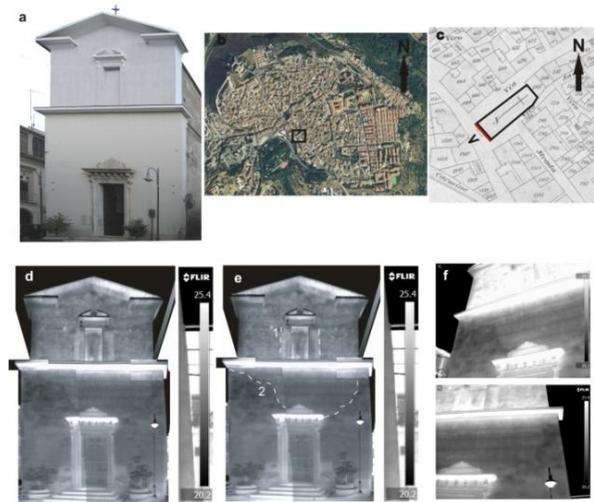
Figure 2 - Santa Maria ad Nives church: current image of front facade (a) localization of the building (b), and of the investigated wall (c) Heat map of the facade (d) and indication of the reconstruction elements (dotted lines 1-2) (e); details of thermal maps with lines of reconstruction

As a result of the 1930 earthquake, damage was recorded to the lateral walls, the front façade, and the front wall of the tympanum. Furthermore, the building suffered partial collapse of the roof and damage to the inner vaults and the bell tower. After the 1980 earthquake the church was affected only by slight damage on the right lateral wall. A comparison between the documented repair works carried out after the 1930 earthquake and the infrared images highlights the likely starting point of the reconstruction process. In particular, the thermal image of the main façade reveals a boundary with an irregular trajectory, extending from the lateral section of the façade to the architrave above the main entrance (Figure 2d-f).

This thermal signature corresponds with the area described in the historical and technical documentation as having undergone repair. The irregular shape of the detected boundary can suggest a non-uniform reconstruction effort, possibly influenced by varying degrees of structural damage sustained during the earthquake.
