XRF and Raman Spectroscopic Study of Wall Polychromes in the Saltworks Castle in Wieliczka

Abstract – This study presents a comprehensive spectroscopic investigation of polychrome wall decorations recently uncovered in the Northern Wing of the Saltworks Castle in Wieliczka, Poland. Believed to date from the 16th to 19th centuries, these multi-layered wall paintings - remarkable for their secular context and heraldic motifs - were examined using X-ray fluorescence (XRF), Raman spectroscopy (RS), and Fourier-transform infrared spectroscopy (FTIR). The analysis focused on pigments and binders, confirming the use of 17th-century materials such as smalt, vermilion, malachite, lead-tin yellow, and protein-based binding media. The findings validate historical assumptions about the chronology and function of these rooms.

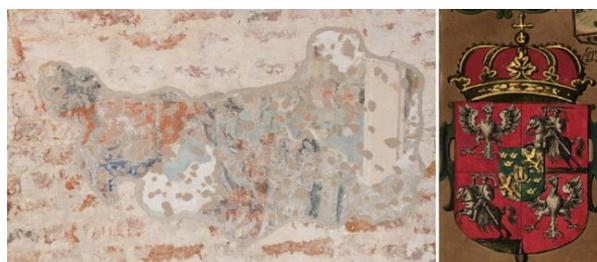
Fig. 2. Detail of the wall painting located in Room 1.2, depicting the coat of arms of the Polish-Lithuanian Commonwealth under the Vasa dynasty (southern wall), shown alongside a historical map titled Image of the Wieliczka Salt Mine and the City of Wieliczka, created by Willem Hondius in 1645.

Figure 2 shows the oldest preserved wall decoration (1.2,III) from Room 1.2. On the southern wall, a fragment of a heraldic composition is visible, featuring the coat of arms of the Polish-Lithuanian Commonwealth during the Vasa dynasty (1587–1668).

The heraldic composition includes a crowned white eagle and the Lithuanian Pahonia, arranged in alternating fields. In the center, remnants of the Swedish royal coat of arms are visible - three grey crowns on blue - though other elements, such as the Folkung lion and the Vasa family's wheat sheaf, have not survived. Small remnants suggest the original decoration included a green cartouche and a golden crown. The shield layout corresponds to that in the royal Vasa chapel in Kraków (1664-1666), confirming its official character. Its presence in Wieliczka Castle - a secular site focused on salt production - is particularly rare, as polychrome wall paintings from the 16th and 17th centuries are typically preserved in religious buildings. The discovery of this official emblem in a secular context suggests that the castle served ceremonial functions and hosted royal visitors, such as Queen Maria Kazimiera in 1683. Thus, the discovery of this unique coat of arms painting not only enhances our understanding of the castle's status but also contributes significantly to Poland's cultural heritage.

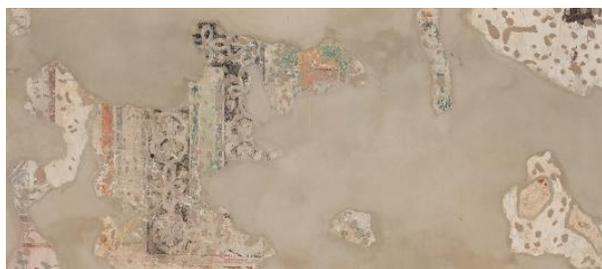
Fig. 3. Detail of the wall painting located in Room 1.3.

In Room 1.3, the preserved fragmentary polychromy (1.3,IV) shown in Figure 3 was examined. It has been preliminarily dated to the 17th century. On the western wall, it forms an ornamental decoration in shades of green, red, ochre, blue, and grey, with the pattern accentuated in black. On the remaining walls, the painted layer is visible in smaller fragments. The dominant colours of this polychrome layer include red, blue, black, green, ochre, and grey.
