Application of Digital Photogrammetry in Damage Mapping on Facades of Historical Buildings

Tallis Rubens¹, Fabiana Oliveira¹, Fabricio Costa², Luciana Toledo³, Ana Elisabete Jacintho³

Abstract – Digital photogrammetry, especially through the use of drones, has proven to be an efficient, accurate, and low-cost alternative for mapping damage on the facades of historical buildings. This paper presents a case study applied to the *Solar do Barão de Itapura*, in Campinas, São Paulo, aiming at the creation of a detailed orthophoto with the identification and classification of pathological manifestations. The methodology includes visual inspection, flight planning, image capture, point cloud processing using Agisoft Metashape Pro software, and analysis of the generated products such as 3D meshes and orthophotos. The results demonstrate the applicability of the technique as an auxiliary tool for identifying and diagnosing pathological conditions in heritage building facades, enabling more well-founded restoration interventions.

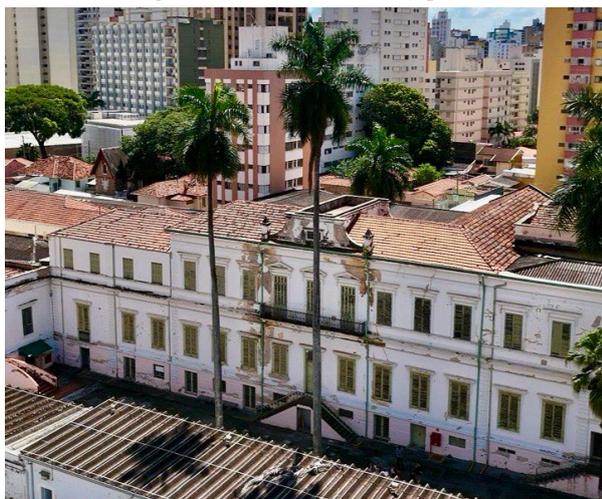
Fig. 1. *Solar do Barão de Itapura*

The *Solar do Barão de Itapura* is an example of 19th-century urban residential architecture in Campinas, São Paulo, combining historical, aesthetic, and symbolic values within the context of the São Paulo coffee elite (Figure 1). Built by Joaquim Policarpo Aranha, the Baron of Itapura, the building features a brick masonry construction system and classical compositional elements such as Ionic-order columns. The main facade, in the Italian Renaissance style, is characterized by full arch windows on the ground floor and straight lintels topped with small triangular pediments on the upper floor—

features also present on the left-side facade, facing the *Pátio dos Leões*. Throughout its history, particularly after its adaptation for institutional use by the *Pontifical Catholic University of Campinas* (PUC-Campinas), the building underwent significant changes. These included the construction of bathrooms, the replacement of original wooden shutters with glass windows, and the addition of roof structures over the terraces—interventions that partially compromised its formal integrity [18], [19].

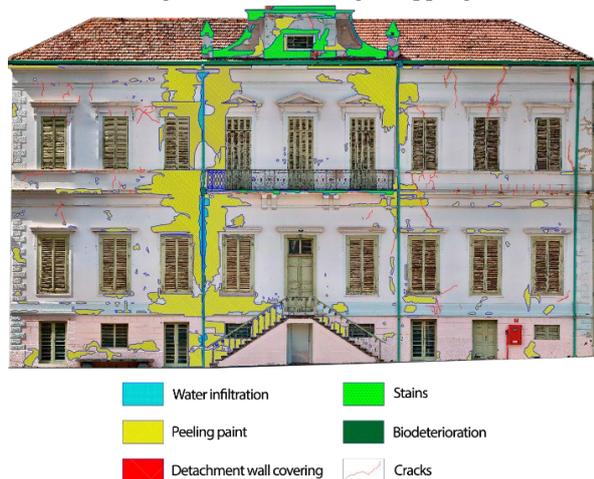
Fig. 8. Facade damage mapping

Figure 8 reveals, through visual analysis, the presence of several pathological manifestations, namely: detachment of coating and paint, vertical cracks and fissures, moisture stains, biodeterioration, and the presence of small vegetation.

Table 5 shows the number of pathological manifestations found on the facade, the central section of the building.

Pathological manifestations	Quantities
Water infiltration	3 points
Peeling paint	44.8722 m ²
Detachment wall covering	0.0838 m ²
Stains	7.8501 m ²
Biodeterioration	1 point
Cracks	128 points

Through the examination of the orthophoto, various pathological manifestations were identified, including detachment of coating and paint, vertical cracks and fissures, moisture stains, biodeterioration (such as fungi and algae), and the presence of small vegetation. In this first study, the identification and classification of pathological manifestations were performed manually.
