# Implementation of Management Facilitators in Historic Buildings: Integration of BIM and GIS for Pathology Monitoring

**The efficient management of historic buildings requires innovative preservation and pathological monitoring methods. This study proposes the integration of Building Information Modeling (BIM) and Geographic Information Systems (GIS) to optimize the conservation of ruined structures, using the former prison of Ilha Anchieta State Park (PEIA) as a case study. The methodology included (1) historical and structural data collection, (2) BIM modeling in Revit, (3) geospatial mapping of anomalies in QGIS, and (4) the definition of maintenance priorities. The results demonstrate that combining these technologies enables the precise tracking of cracks, fissures, and displacements and facilitates preventive interventions. The study outlines a five-step guideline, from data collection to action planning, providing a replicable method for other historic buildings. It is concluded that the proposed approach improves the efficiency of heritage management, reduces costs, and contributes to the preservation of structural originality, with the potential for expansion through aut

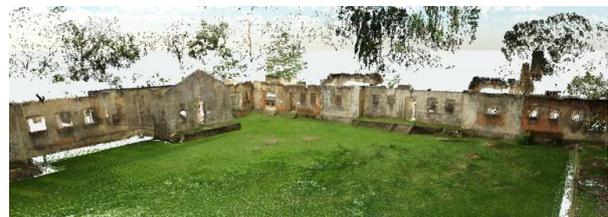
The point cloud was imported into Revit, and all architectural components were manually modeled by overlaying them onto this reference base. For modeling specific families (e.g., doors, windows, railings), a point cloud file in DXF format was imported into the family editor environment. This was necessary because Revit does not support other point cloud formats in this specific workspace. This DXF file was generated using the open-source software CloudCompare (v2.9.1) from the laser scan data, which was first converted to LAS format using Faro Scene software, as illustrated in Fig. 1.

*Fig. 1. Image of the point cloud generated by the Scene program*

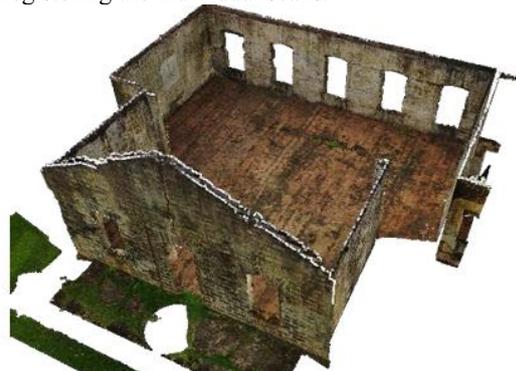
Internal scans were performed for each pavilion and the other buildings, except for the Administration building. The scanner positions were determined based on the number of rooms in each area. Pavilion 6, for example, required two internal scan positions and one external scan position. Fig. 2 shows the point cloud generated by registering the individual scans.

*Fig. 2. Record of the three laser shots with a view of the facade and back wall*

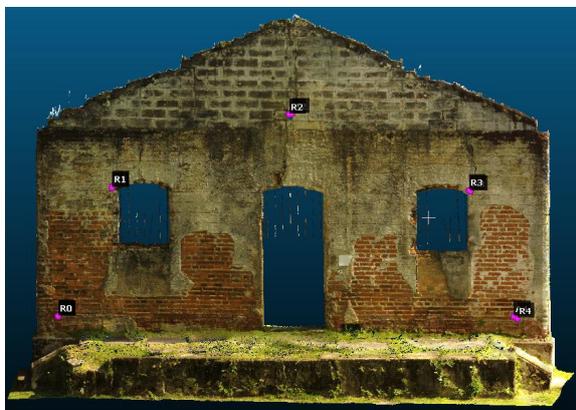
Figure 8 shows the pavilion image obtained from

CloudCompare, with the points aligned as indicated in the images and with the data already calculated from the topographic survey data.

Fig. 8. Point cloud in CloudCompare with aligned points – Clay brick facade
