Walls of the Castle of Alcácer do Sal – Contribution to the Study of Mortars in Military Architecture

Abstract – The strategic location of Alcácer do Sal, on the banks of the Sado River and in a region rich in natural resources, explains the various occupations of this territory throughout history. However, it was the influence of the Muslim occupation (715–1217) that stood out the most, still visible today through archaeological remains, the town's name, and, in this case study, the castle walls (11th–12th centuries), which have undergone several interventions over time.

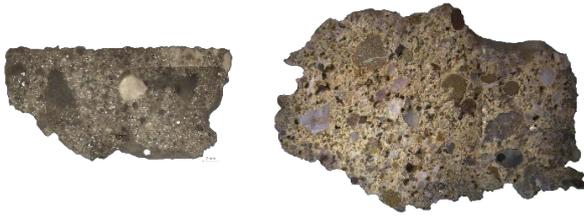
Fig. 2. Examples of samples (ALC3, ALC6) with brown homogeneous binder.

Based on visual and stereo microscopy observations, the samples were grouped according to their binder color and aggregate characteristics. Most samples presented a homogeneous binder, ranging from light to dark brown (fig.2). Exceptions include samples ALC1A and ALC1B (Zone 1) with black-colored binders, ALC8E (Zone 4) with a whitish tone, and ALC10TR (Zone 5) with a greyish lower layer (fig.3). These chromatic differences may indicate construction in distinct chronological phases.
