Mineralogical and petrographic analyses of a complex finishing plasters stratigraphy from a 17th century Sardinian Church

Abstract – The work concerns the study of the original layers of mortar and finishing used in two historical phases of the Church of Madonna d'Itria in Orani (central Sardinia, Italy) which was built in the 17th century. The aim is to analyse the finishing pigmented layers that were superimposed between the 17th and 20th centuries. Furthermore, the study includes the analysis of the mortar substrate on which the pigmented layers were applied, to study their adhesion, mechanical resistance and composition. The general aim of the work is to highlight the techniques and raw materials used for made the finishing plasters and the presence of chemical-physical alteration processes aimed at restoration interventions.

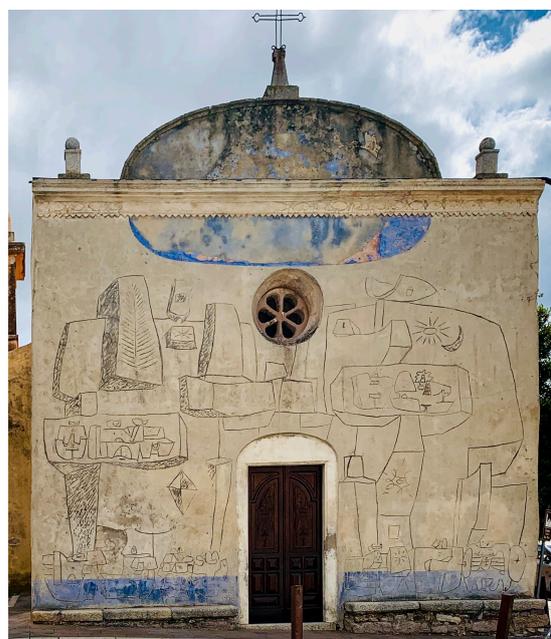
The main façade of Madonna d'Itria from Orani (Fig. 1), is surmounted by a curvilinear tympanum, has a small rose window above the entrance portal. On the northern façade of the monument is the tall square-plant bell tower of late Baroque style. The single-nave, barrel-vaulted building with narrow side chapels features a Gothic-style presbytery with a ribbed cross vault. This is decorated with *mezzo-fresco* [1] paintings from the late 17th century depicting angels and cherubs playing music, and in the apse the Triumph of Christ and the Last Judgement. The main altar houses the valuable wooden sculpture dedicated to the Madonna d'Itria, dating back to the 17th century, decorated with the *estofado de oro* technique. The façade features *graffito* created in 1958 by Costantino Nivola, representing the battle of Lepanto. The research aim is to study the compositional features of mortars and paints used in different times on the main façade of the Church according to the methodologies and analytical techniques well known in the literature [2, 3, 4].

Fig. 1. Façade of the Madonna d'Itria Church from Orani village (Central Sardinia).

On the façade (Fig. 2), above the original ochre paint (17th century), a pink finishing paint can be observed, applied between the 17th and 20th centuries.

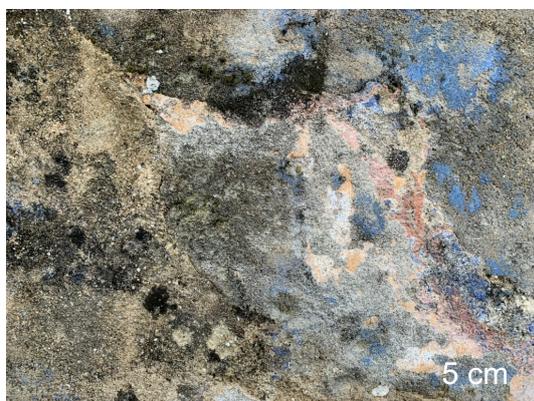
Fig. 2. Detail on a portion of top façade (near to the timpano) with different mortars and finishing paints.

The stratigraphy of the Church's façade is complex due to the presence of different construction / intervention phases to which the materials refer (Fig. 2). By macroscopic and microscopic observations, in chronological order, the finishing works (plaster, pigmented mural paintings, etc.) on the Church's façade are shown as follows.

- plaster mortar (whitish 2nd outermost layer, Fig. 3, 4);
- blue paint present on the upper part of the façade and adhering partly to the original plaster mortar and partly over the white lime paint (*scialbo*), sometimes slightly light blue in colour due to the overlying layer of blue paint (Fig. 2);

- blue paint present on the base of the façade and adhering to the original plaster mortar (Fig. 2).

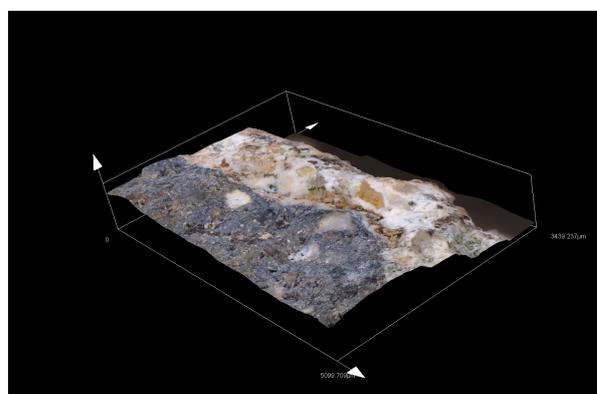
Fig. 3. 3D view image by digital optical microscopy of a sample with two mortars layers (greyish and whitish) made by Nivola on the façade.

- dark plaster mortar (greyish 1st innermost layer, Fig. 3, 4) adhering directly to the original plaster mortar from the original phase (?) and to the base plaster mortar prepared by Nivola;

The two mortar layers, belonging to the recent finishing interventions made by Nivola artist (in 1958), in turn have different features. The external whitish mortar layer (Fig. 3, 4) has a lime-based binder (now carbonated in calcite) and an aggregate composed of quartz, plagioclase, K-feldspar and phyllosilicates (biotite and chlorite). The internal greyish innermost layer has a similar composition in the aggregate while the binder appears different in macroscopic characteristics with a dark colour.

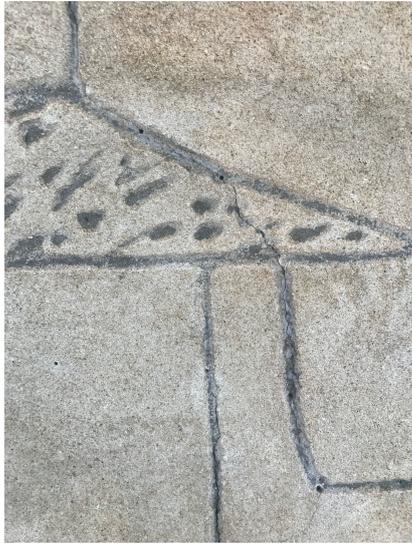
Fig. 4. Detail of greyish and blackish mortar works by Nivola on the façade of the Church.

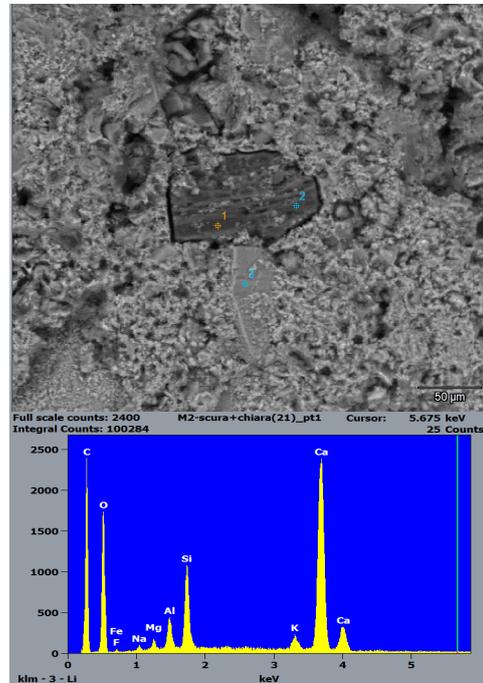
Fig. 5. Detail of the first greyish mortar layer in a hydraulic binder-rich area with a organic fragment (from the structure it could be wood or coal; note the intensity of the carbon signal in the spectrum of points 1 and 2); analysis point 3 refers to a K-feldspar of aggregate.

Finally, the first dark layer of mortar presents a higher background which suggests the presence of a certain quantity of amorphous or slightly crystalline phases, a characteristic compatible with the presence of a certain quantity of hydraulic binder (C-S-H or C-A-H phases), or deriving from the residual amorphous phases of ashes from burning wood (or coal) probably used in the mixture by Nivola to darken the mortar [6].

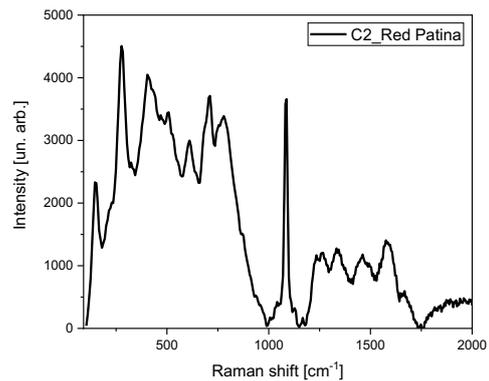
Fig. 6. Raman pattern of pinkish pigmented paint present in the façade (realized in 17th-20th) of the Church.

different composition between the pinkish pigmented fine lime-based paint realized before 20th century (Fig. 6, Tab. 1) and the recent 20th century blue finishing plaster on upper façade by Nivola artist (Fig. 7, Tab. 2).

The pinkish pigment shows a based hematite composition, while the blue pigment used by Nivola a mix of azurite and subordinated Scheele green and lazurite.

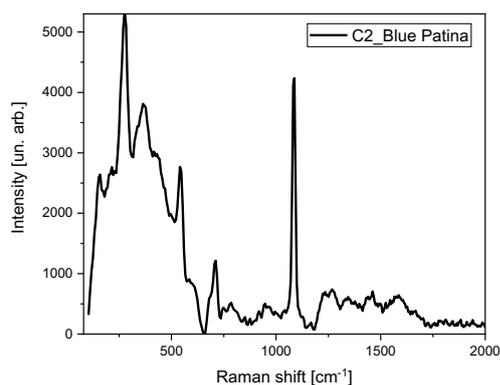
Fig. 7. Raman pattern of blue pigmented paint present in the upper façade of the Church.

of quartz, K-feldspar, plagioclase, and crystalline phyllosilicate phases likely originating from granitoid rocks. For the external whitish layer, a binder based on hydrated lime (now carbonated to calcite) and a silicate aggregate very similar to that of the previous layer were used. On top of the pre-existing mortars, partly original, partly belonging to the lime-based plaster base applied by Nivola himself to level the external surface, in the upper part (tympanum) and at the base of the church's façade the artist used as a blue lime-based paint using a pigment mix of azurite and subordinated Scheele green, lazurite.
