Surface Features of the Giovanni Rasori marble monument (1840, Milan): chemical characterization of degradation and past restoration interventions

Abstract – The conservation of outdoor heritage in urban environments requires careful analysis of degradation processes induced by atmospheric pollutants. This study presents the results of a scientific investigation on the marble monument of Giovanni Rasori (1840), located in Milan, a city affected by heavy traffic and industrial emissions. Exposed for decades to an outdoor polluted environment, the monument exhibited visible signs of surface alteration. Analytical techniques, including SEM-EDX and ATR/FTIR, revealed that the primary degradation process was sulfation, confirmed by the presence of gypsum on the marble substrate. Moreover, the detection of Ti in localized areas of certain micro-fragments suggests the possible use of a whitening agent or pigment during past restoration works. Additionally, the co-presence of elements such as Si, Al, and Fe may be linked to atmospheric dust or to abrasive residues from earlier cleaning practices, such as micro-sandblasting, historically used in stone conservation. These findings contribut

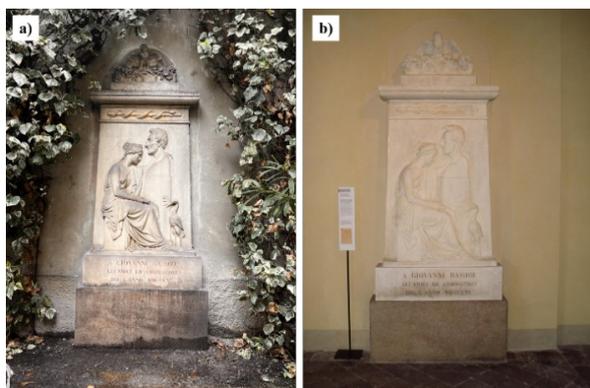
Fig. 1. Location of the Giovanni Rasori monument before (a) and after (b) the 2024 restoration. a) outside the Historical Archive; b) inside the vestibule of the Archive, Milan.

The composition is dominated by a female figure, presumably Hygieia, the goddess of health and hygiene, embracing the sculpted bust of the physician. Above, the owl of Athena, resting on a book, symbolizes wisdom, while the Rod of Asclepius, entwined by a serpent, represents the medical profession. On the right, a stork symbolizes filial piety [9-10]. The monument is surmounted by a bas-relief depicting an owl resting on a bed of flowers. The marble monument measures 242 cm in height and 115 cm in width [9-10]. Originally located under the portico of the courtyard of the IRCCS (Scientific Institute for Research, Hospitalization and Healthcare) Ca' Granda Foundation, Ospedale Maggiore Policlinico, located in the centre of Milan, the monument underwent an initial restoration in 1918, limited to a surface cleaning. During the post-war reconstruction, likely in the 1960s, the monument was relocated (possibly also subjected to undocumented restoration) into the courtyard of the Historical Archive (Fig. 1a), where prolonged exposure to atmospheric agents and pollutants progressively led to various forms of deterioration, including corrosion, surface deposits, and biological growth. In 2024, the monument underwent a new conservation intervention, carried out by the Centro Studi e Conservazione Piccolo Chiostrò. The sculpture was dismantled and transferred to a controlled indoor environment for conservation operations and was later reassembled and relocated to its current position in the vestibule of the Archive (Fig. 1b).

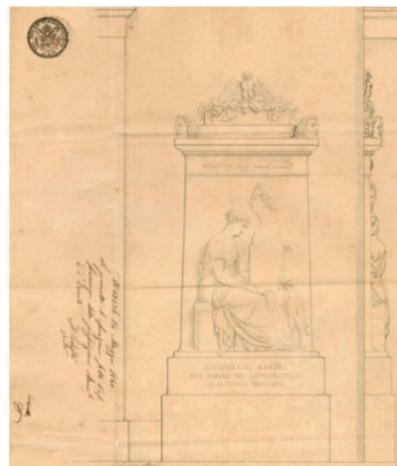
Fig. 2. Design of the commemorative monument to Giovanni Rasori, 1840, pencil and ink on paper, Milan, Historical Archive of the Ospedale Maggiore.

to commemorate him was made in 1838, followed by a public fundraising campaign in 1841. The monument construction was entrusted to the acclaimed sculptor Benedetto Cacciatori (1794–1871), a Neoclassical school artist from Carrara, who created the marble work with a rich symbolic iconography (Fig. 2).

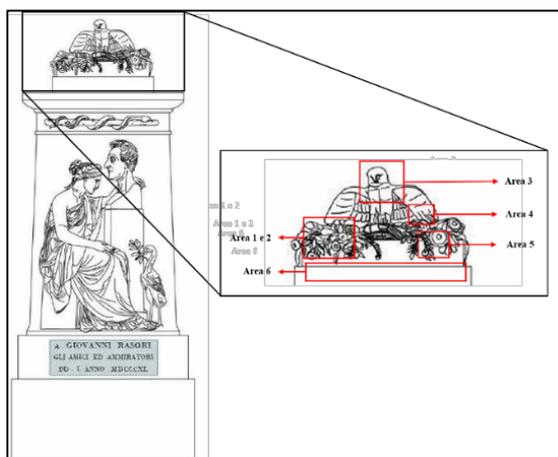
Fig. 3. Drawing of the Monument to Giovanni Rasori with the indication of the sampling areas. The image highlights the zones from which microsamples were collected for analytical investigation.

Sampling was carried out by collecting powders and micro-fragments from various areas of the monument with a scalpel (Fig. 3). Areas 1 and 2, which were affected by the same degradation patina, were grouped and analyzed as Sample 1. Similarly, areas 3 and 4 were combined and designated as Sample 2. In contrast, Samples 3 and 4 were collected from distinct locations (area 5 and 6, respectively) and analyzed individually. Details of these samples are provided in Table 1.

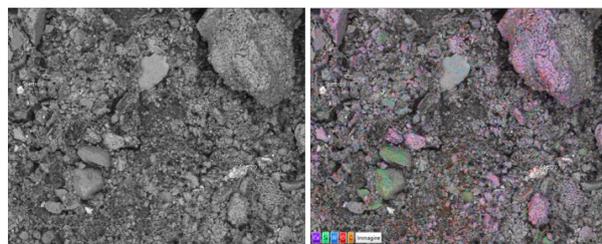
Fig. 4. SEM images of Sample 1. Left: micrograph in SE mode (Secondary Electrons). Right: false-color elemental map of the main chemical elements.

SEM was used to acquire representative images of the sample surfaces. As an example, an image of Sample 1 acquired in SE (Secondary Electrons) mode is presented in Figure 4 (left). Moreover, a false-colour elemental map was obtained using EDX (Fig. 4, right), illustrating the spatial distribution of the main chemical elements.

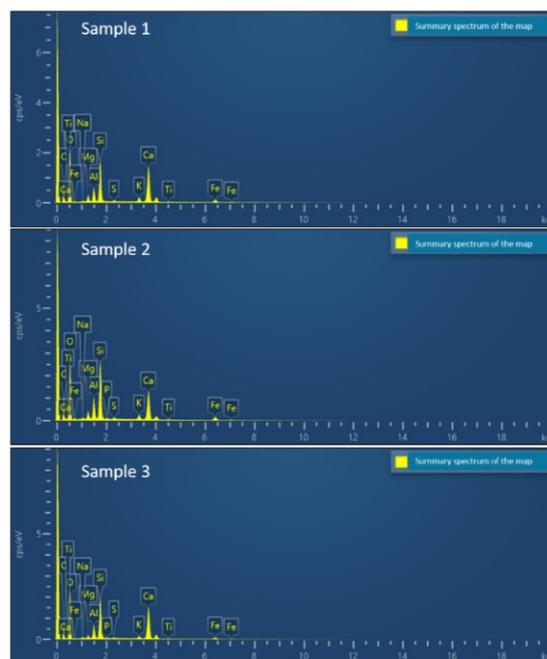
Fig. 5. EDX spectra of Samples 1, 2, and 3.

Overall, EDX analysis conducted on all samples revealed a chemical composition consistently dominated by C and Ca, consistent with a substrate primarily composed of calcium carbonate (Fig. 5).

Of particular interest is the presence of titanium in all of the samples. The low intensity of the corresponding peak in the EDX spectra indicates a lower concentration compared to the other elements. However, additional analysis on micro-fragments (Fig.6) show a particular distribution indicating the intentional application of a titanium-based material, possibly used as a whitening agent or pigment during a past surface retouching or conservation treatment. Indeed, it is known that titanium dioxide (TiO_2) was widely employed in conservation and architectural coatings due to its excellent opacity and whiteness [11].

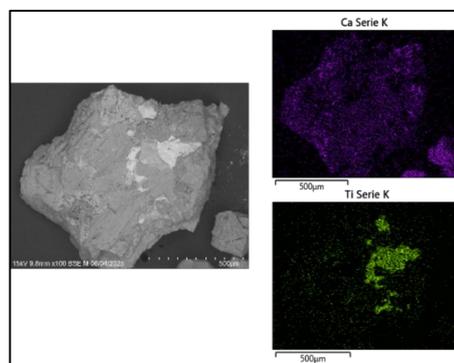
Fig. 6. SEM image and elemental maps showing the distribution of Ca and Ti of a micro-fragment.

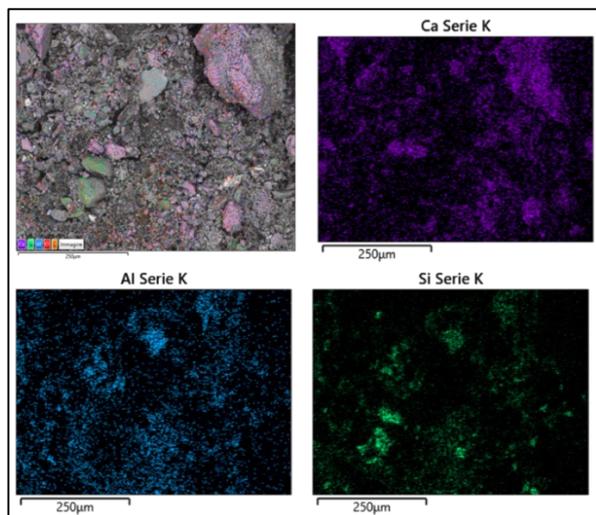
Fig. 7. SEM micrograph of a micro-fragment; false-colour elemental maps show the spatial distribution of calcium (Ca), aluminium (Al) and silicon (Si).

Moving on, the simultaneous detection of aluminium, silicon, iron, potassium and magnesium, could be due to atmospheric particulate matter deposition (Fig. 7).

These particles, deposited through atmospheric transport and precipitation, are commonly found on stone surfaces exposed to polluted urban environments and can lead to the accumulation of alteration layers. A second hypothesis considers the possible historical use of abrasive cleaning techniques, particularly micro-sandblasting with alumina (Al_2O_3). This method was widely employed between the 1940s and 1960s for the removal of encrustations and surface deposits from stone materials. The alumina-based abrasives used at that time were often not chemically pure, consisting of natural or synthetic corundum with significant impurities of silica (SiO_2) and iron oxides (Fe_2O_3). The presence of these elements in the analysed samples is consistent with residues potentially associated with such treatments. These abrasive materials are known to leave persistent micro-residues on treated surfaces and to alter the substrate's microstructure, increasing both porosity and susceptibility to further degradation [12-13]. It is plausible that this type of intervention occurred during the post-war relocation of the monument to the courtyard of the Historical Archive, likely in the 1960s. The presence in low concentration of K and Mg in all samples can also be attributed to biological activity, such as colonization by algae, lichens, or microbial communities. These organisms are frequently observed in outdoor stone monuments and are associated with biodeterioration phenomena, both through physical biofilm formation and chemical action via metabolic by-products [14].

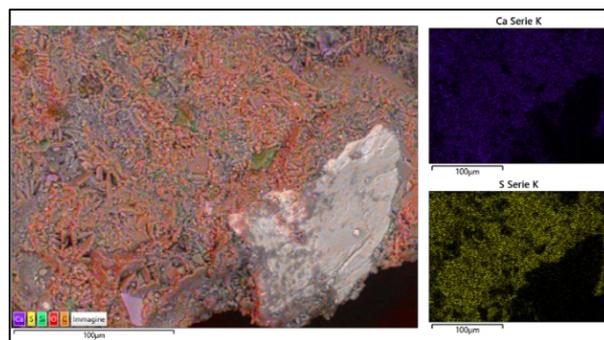
Fig. 8. SEM micrograph of sample 1; false-colour elemental maps show the spatial distribution of calcium and sulfur.

Furthermore, the co-presence of calcium and sulphur in Sample 1 (Fig. 8) suggests the formation of gypsum

($CaSO_4 \cdot 2H_2O$), a common indicator of the sulfation processes typically observed on calcareous stone surfaces exposed to urban environments [15-16]. These processes generally result from the interaction of airborne sulfur oxides (e.g., SO_2) with calcium carbonate in the presence of moisture, leading to the formation of sulphate minerals, black crusts, and granular disintegration.

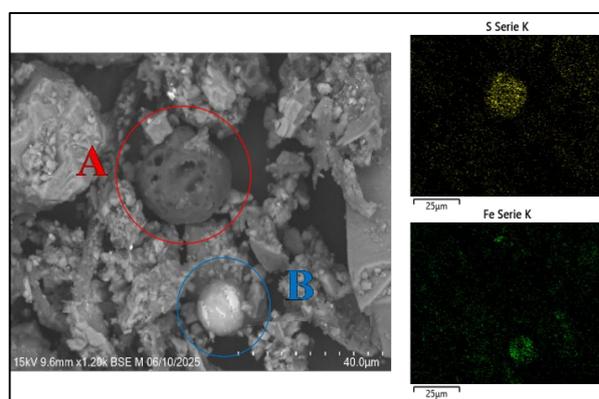
Fig. 9. SEM micrograph in BSE (Back-Scattered Electrons): (A) sub-spherical particle with a porous

surface; (B) spherical particle with smooth surface;
sulphur and iron chemical distribution map of the same
area.

From the SEM images it was also possible to highlight the presence of several particles probably generated by combustion processes [15-16]. Most have a porous surface and a subspherical or irregular shape, around which newly formed gypsum crystals can be observed as in Fig. 9, while others are spherical with a smooth surface. SEM-EDX maps revealed that the porous particles were mainly composed of sulphur and carbon, with lower amounts of iron and, in some cases, also silicon and calcium. These were likely carbonaceous particles containing iron oxides, originating from the combustion of fuel oil used in domestic heating systems, as reported in the literature [15-16]. The smooth spherical particles, on the other hand, were mainly composed of iron and lower amounts of silicon and aluminium, with the typical composition of coal combustion particles (Fig. 7) [17].

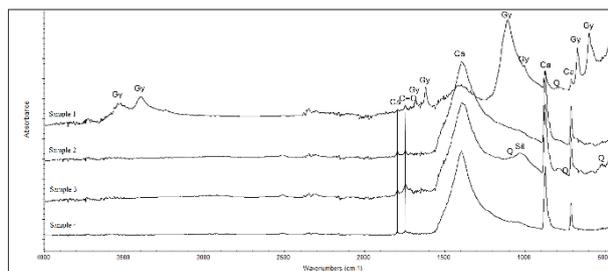
Fig. 10. ATR-FTIR spectra of the analysed samples. Gy = Gypsum; Ca = Calcite; Q = Quartz; Sil = Silicates; Q = Quartz.

ATR-FTIR spectroscopy performed on the powdered samples enabled the identification of the main mineralogical components as well as some organic functional groups (Fig. 10). All samples exhibited intense signals attributable to calcite, with characteristic peaks located at approximately at 1796, 1397–1403, 871, and 713 cm^{-1} , confirming the predominance of calcium carbonate (CaCO_3) as the primary lithic substrate. In Sample 1, the presence of gypsum ($\text{CaSO}_4 \cdot 2\text{H}_2\text{O}$) was clearly identified based on its diagnostic OH and sulfate bands at 3525, 3395, 1682, 1618, 1106, 1001, 669, and 599 cm^{-1} . This finding supports the hypothesis of sulfation-related alteration, as previously suggested by the results of SEM-EDX analysis.

Moreover, quartz was detected in both Sample 1 and Sample 3, as indicated by the bands at 798 and 779 cm^{-1} , and in Sample 3 additionally at 1083 and 513 cm^{-1} . Moreover, Sample 3 exhibited a band at 1030 cm^{-1} , consistent with the presence of silicates. These mineral species may derive from terrigenous dust deposited on the surface or be attributed to residues from previous restoration treatments, such as abrasive materials.

Finally, all samples showed a weak but distinct carbonyl ($\text{C}=\text{O}$) band in the range of 1745–1750 cm^{-1} that could be due to the presence of organic residues, such as degraded binders or conservation products. Nevertheless, the absence of characteristic aliphatic $\text{C}-\text{H}$ stretching bands around 2900–2800 cm^{-1} makes the presence of a well-preserved organic component unlikely.
