# The Roman mosaic in the Nymphaeum of Villa Giulia in Rome. Characterization of the deteriorogen agents and preliminary experimentation of eco-sustainable products

**Abstract** - One of the current challenges facing restorers and conservators of cultural heritage is to ensure the right balance between treatment efficacy, long-term conservation and reduced environmental impact. Certain cases, such as that of the Nymphaeum of Villa Giulia in Rome, the three elements cross each other, sometimes making the balance very difficult. The Nymphaeum of Villa Giulia in Rome, designed by the architect Bartolomeo Ammannati in the mid-16th century, is characterized by a complex architectural apparatus and is enriched by refined decorations in stucco, stone materials and statuary. This beauty is placed in an open environment, continuously exposed to soiling and related degradation phenomena, such as darkening caused by accumulation of particulate matter. Therefore, as with all external monuments, it is strongly compromised by degradation phenomena closely connected to the context in which it is located and aggravated by the presence of water from the fountain. In particular, the presence of mic

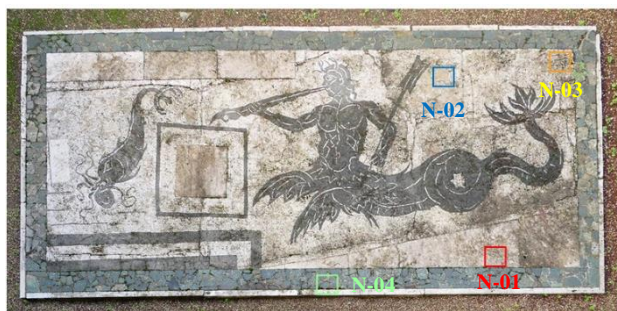
Figure 1. Sampling location.

For a better evaluation of the effectiveness of bio-cleaning it was necessary to characterize the microorganisms present on the mosaic. Figure 1 shows the sampling areas, and Table 1 lists the biological patina present of the mosaic. The biological analyses were performed in collaboration with Tecno.el srl and the "Charles Darwin" Department of Biology and Biotechnology of the "Sapienza" University of Rome. The steps were:

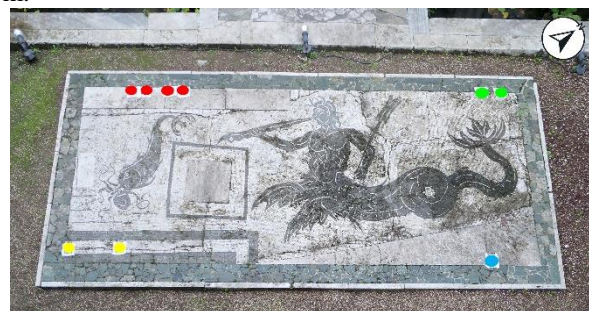
Figure 2. Area treated.

The gel-supported enzymes and traditional free enzyme cleaning patches were compared to evaluate their efficacy. Table 2 reports the cleaning treatment for each investigated area. Four different areas of the mosaic have been selected (Figure 2). The first area involves small travertine slabs at the top left (red dots), the second area involves the white tiles near the lower left corner (yellow dots), the third area involves both the white tiles and the frame in green serpentine near the upper right corner (green dots) and the last area involves a travertine slab near the lower right corner (light blue dot). All the areas were not treated with protective film but left in equilibrium with the open environment. The samples area measured 10x10 cm.

This result suggest that traditional free enzymes used in Area 2 and Area 3 are more susceptible to seasonality since a greater oscillation in the repopulation curve was recorded. The different trends of the curves may also depend on a different exposure of the samples and on the different constituent materials (Figure 2).

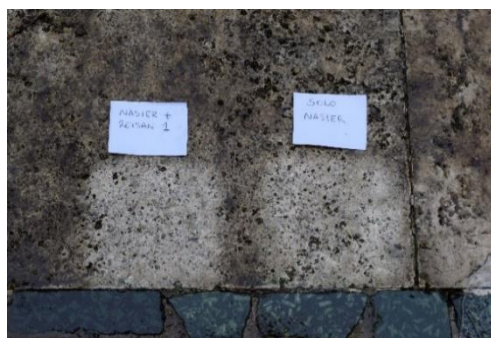
Figure 3. Area treated with only gel-based enzymes and area treated with both gel-based enzymes and essential oils.

The product was composed by peppermint essential oil and had a milky liquid appearance, and it was tested both on the area treated with gel-based enzymes and on the area treated with traditional free enzymes (Figures 3-4).

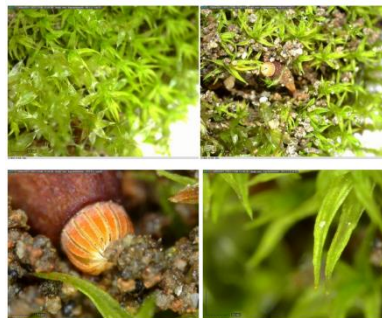
Figure 6. Digital microscope observations of sample N-04 at 50x and 250x.

The diagnostic morphological characters of sample 04 are those typical of the division of Bryophyta, class of Mosses (Figure 6). They are non-vascular plants, whose survival is strongly linked to the presence of water. A preliminary study there allows us to hypothesize that they belong to the *Tortula* genera (most likely *Tortula muralis*), *Bryum* and *Fissidens*. They have not yet been sequenced. The proliferation of mosses is linked to the presence of water.

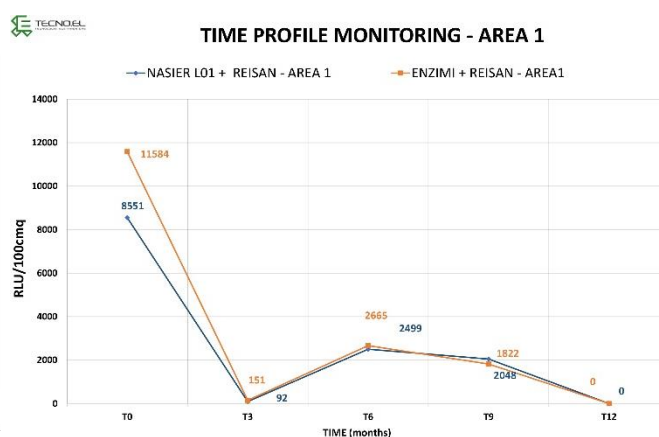
Figure 10. Microbiological repopulation curve. Area 1 (travertine) treated also with essential oil (up to twelve months).

In Area 1 the repopulation curves overlapped (Figure 10). In Area 2 and Area 3 the repopulation curves showed the same trend for up to 3 months after the treatment, but afterwards there was a substantial difference between the two cleaning methods. In the case of the areas treated with gel-based enzymes, the microbiological repopulation showed rather low RLU values, only in Area 3 increased after 9 months. On the other hand, in the areas treated with traditional enzymes after 3 months the RLU values increased by more than double compared to gel-based enzymes, to then record a reduction after 6 months and a subsequent increase between 9 and 12 months (Figures 11-12).
